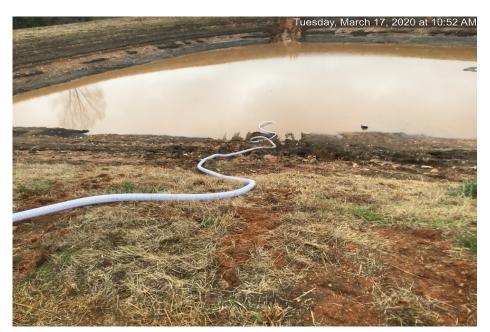
Photograph 31: Removal of liquid waste from Pond 2 continued. Additional rainfall resulted in additional liquid waste to be removed.

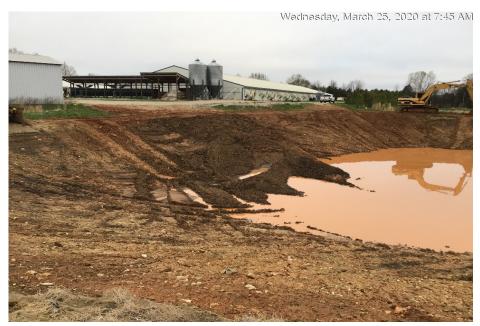
Photograph 32: Removal of solid waste from Pond 1 continued. Additional rainfall resulted in additional liquid waste in Pond 1.

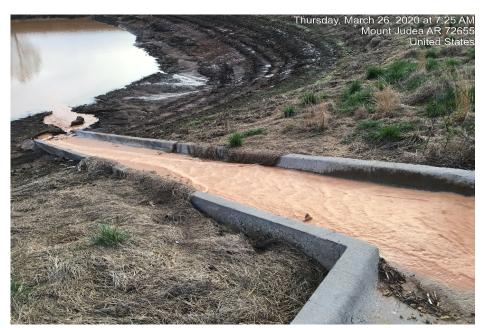
Photograph 33: Liquid waste due to rainfall was pumped from Pond 1 to Pond 2.

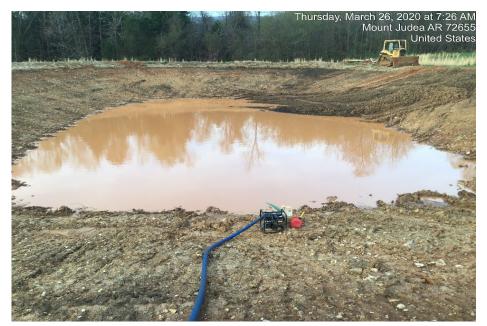
Photograph 34: Liquid waste due to rainfall was pumped from Pond 1 to Pond 2.

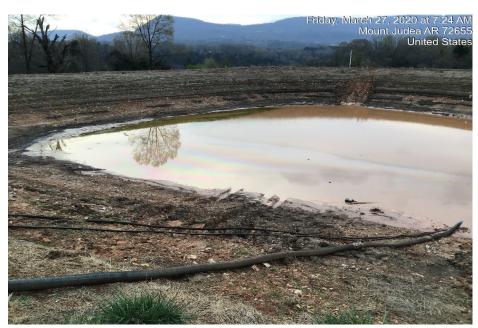
Photograph 35: Removal of liquid waste from Pond 2 continued.

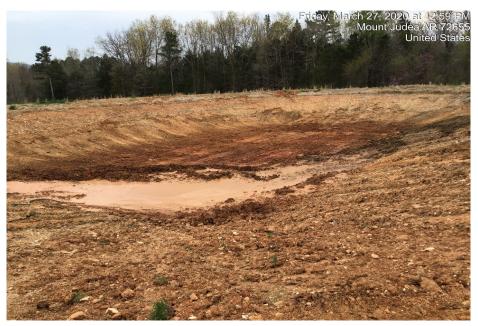
Photograph 36: Pond 1 free of liquid and solid waste.

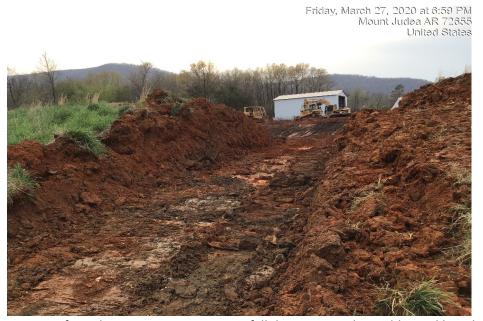
Photograph 37: Levee of Pond 1 was cut to ensure rainfall does not result in additional liquid waste to be removed.

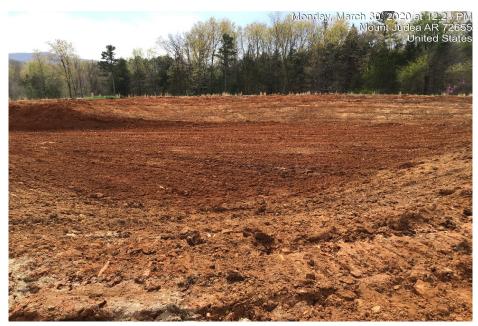
Photograph 38: Pond 1 with all liquid and solid waste removed.

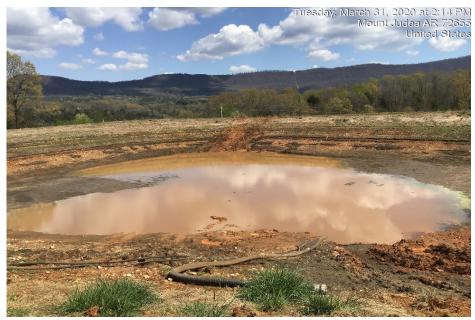
Photograph 39: Additional rainfall resulted in additional liquid waste to be removed from Pond 2.

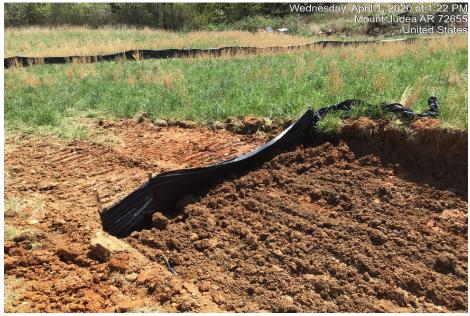
Photograph 40: Silt fence was placed across breach in the levee of Pond 1 to ensure no sediment was allowed to erode during rain events.

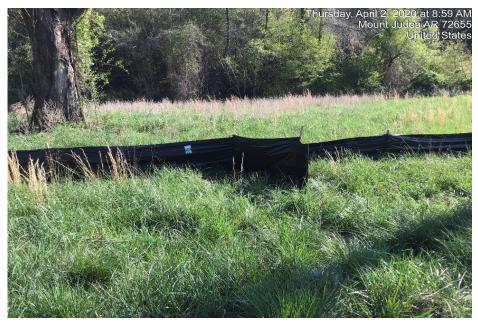
Photograph 41: Slit fence surrounding site was placed.

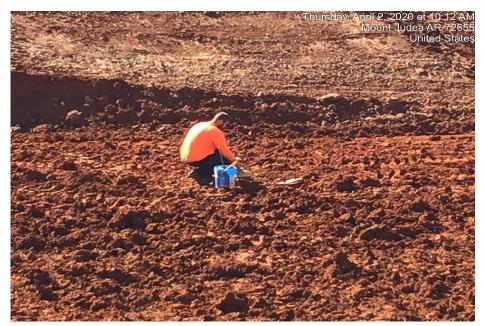
Photograph 42: Soil density testing was required for each lift of material placed.

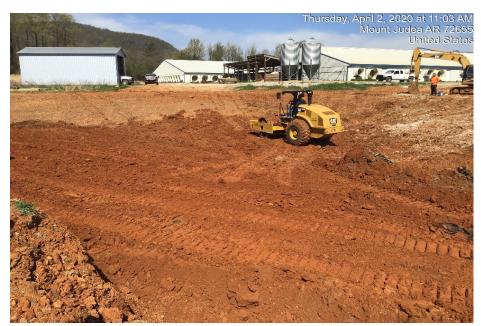
Photograph 43: Material was placed in lifts over Pond 1.

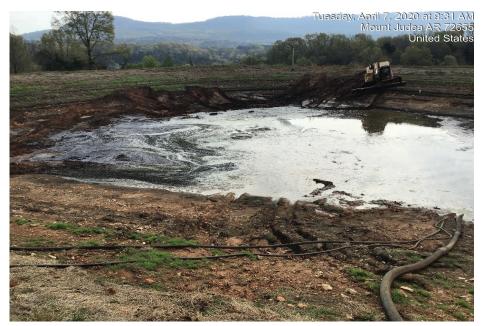
Photograph 44: Pond 2, with most liquid waste removed. Mainly solid waste remained.

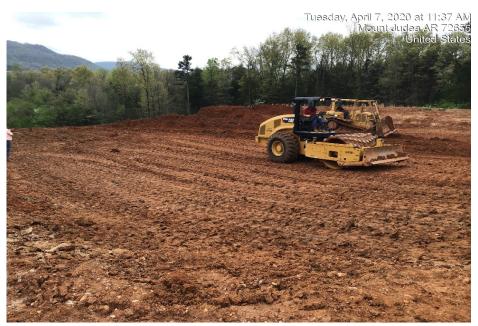
Photograph 45: A lift of material being compacted over the old Pond 1.

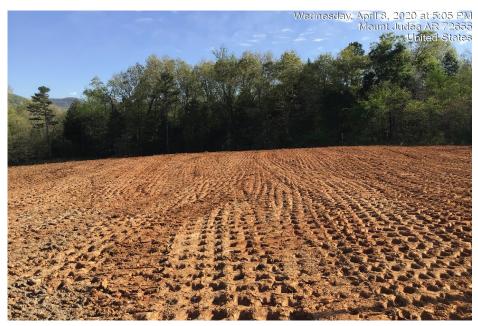
Photograph 46: Material has been placed and compacted over Pond 1.

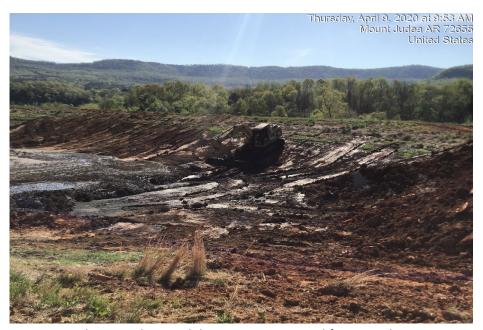
Photograph 47: Solid waste was removed from Pond 2.

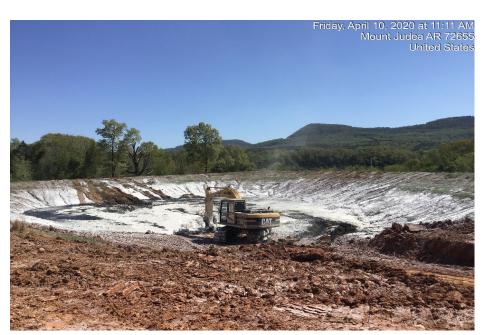
Photograph 48: Lime was added to solid waste in Pond 2 to help solidify solid waste.

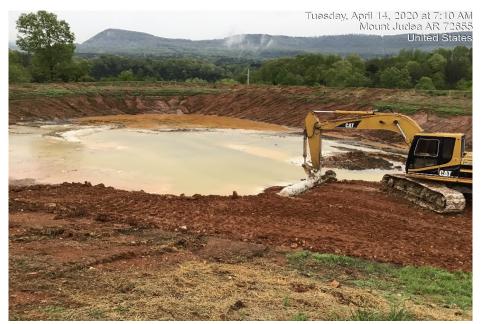
Photograph 49: Additional rainfall resulted in more liquid waste in Pond 2.

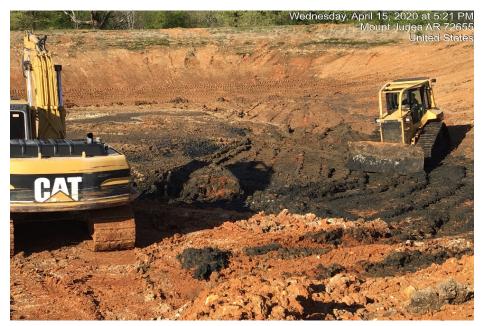
Photograph 50: Solid waste was removed from Pond 2.

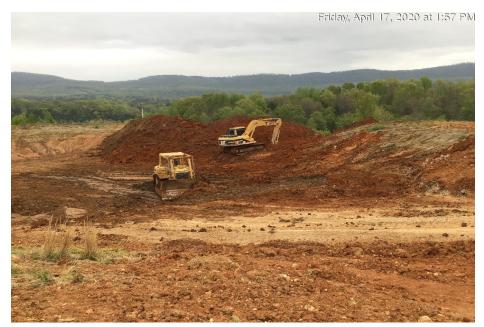
Photograph 51: All solid waste has been removed from Pond 2 and levee was breached to ensure rainfall resulted in no additional liquid waste.

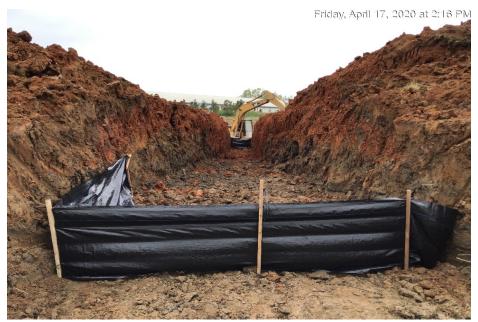
Photograph 52: Levee of Pond 2 breached, and silt fence was placed to ensure no sediment was allowed to erode during rain events.

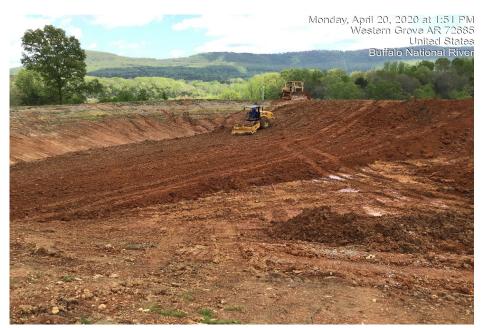
Photograph 53: Material was placed in compacted lifts over Pond 2.

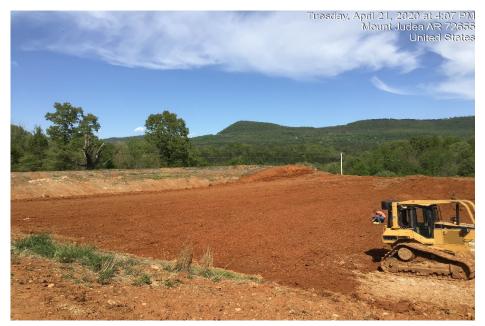
Photograph 54: Material being placed in compacted lifts over Pond 2 continued.

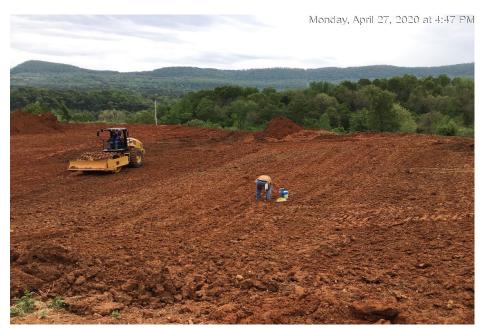
Photograph 55: Soil density testing was conducted on every lift placed.

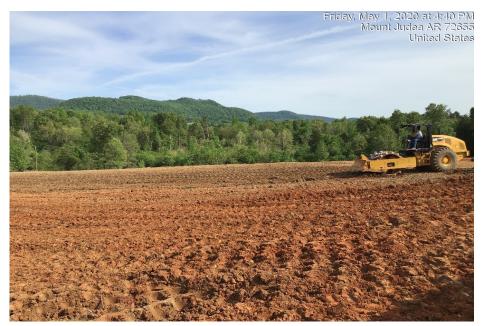
Photograph 56: Material being placed in compacted lifts over Pond 2 continued.

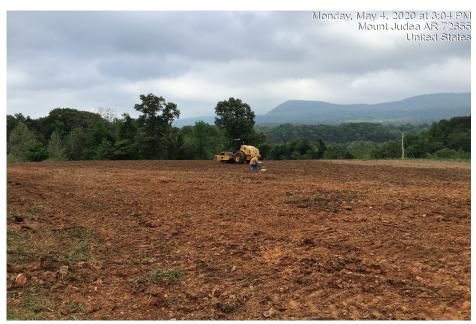
Photograph 57: Material being placed in compacted lifts over Pond 2 continued, and soil density tests continued.
