# Reg 5 Comment Appendices

## Appendix C3 - Review of permeability determination

C&H Hog Farms  
Newton County, Arkansas

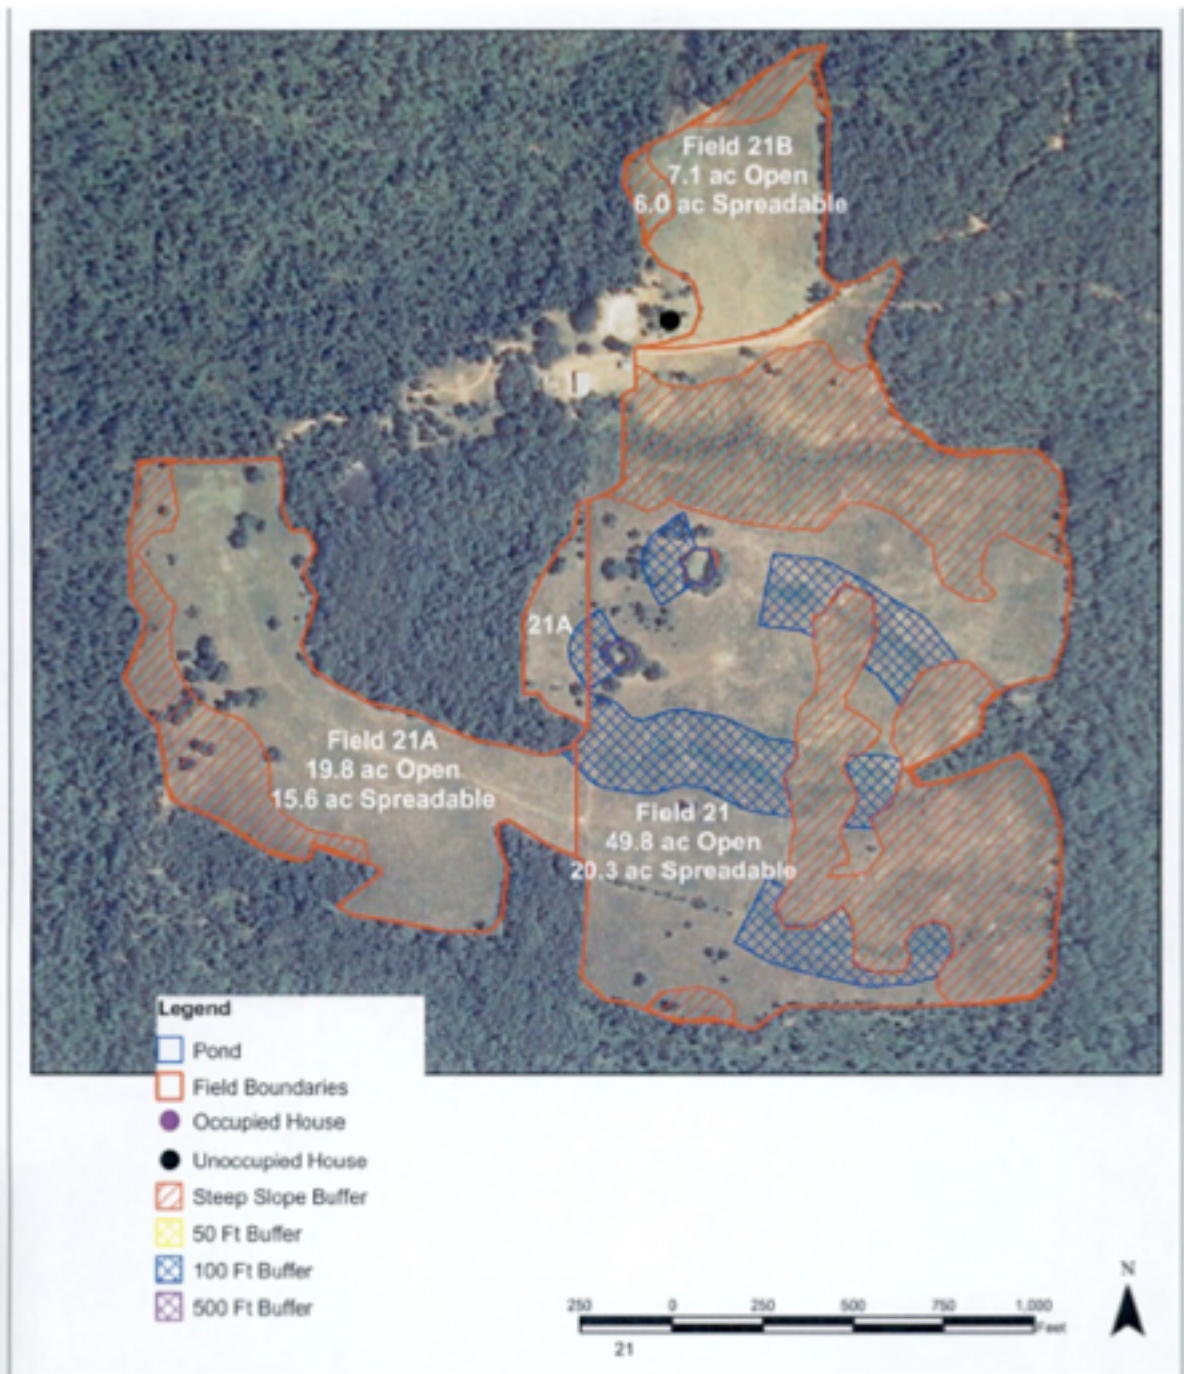
FIGURE 1 EXAMPLE OF A FIELD 21A, WHICH IS CONTORTED AND INAPPROPRIATE FOR WASTE APPLICATION

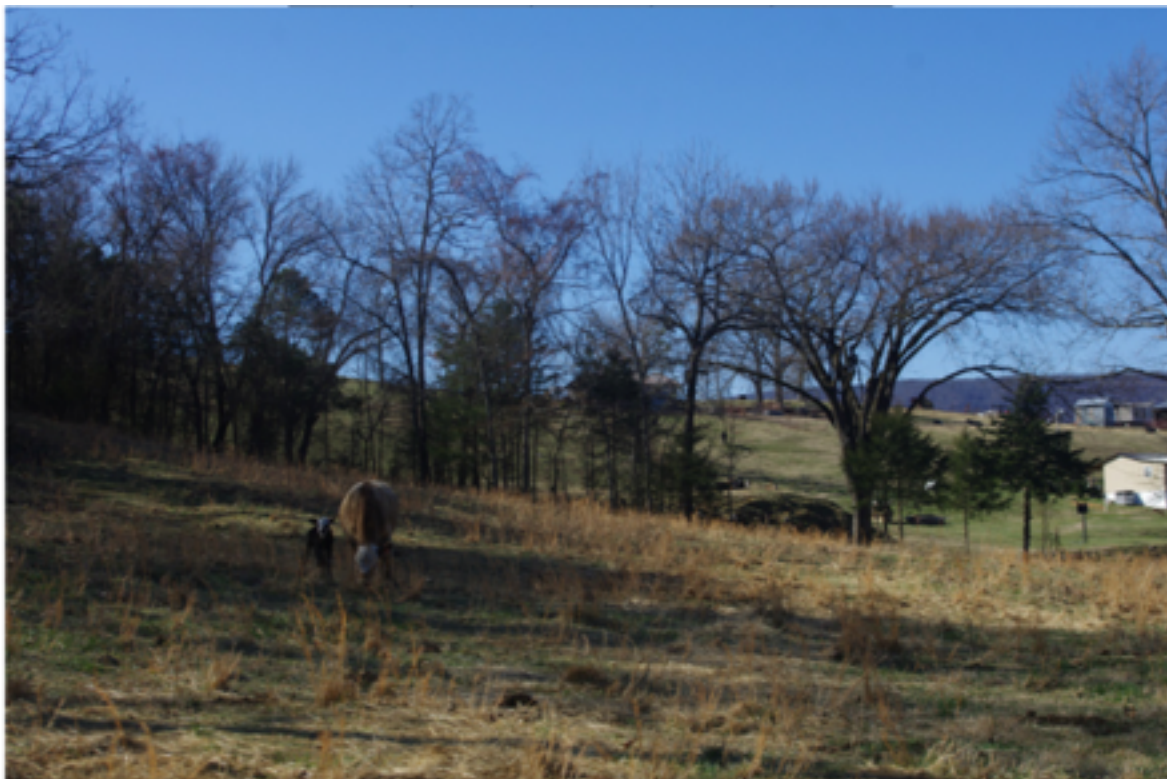
**FIGURE 2 PHOTOGRAPH OF FIELD 2 SHOWING POOR MANAGEMENT OF FORAGE PRODUCTION AND GRAZING. PHOTO BY BRWA TAKEN FEBRUARY 17, 2017.**

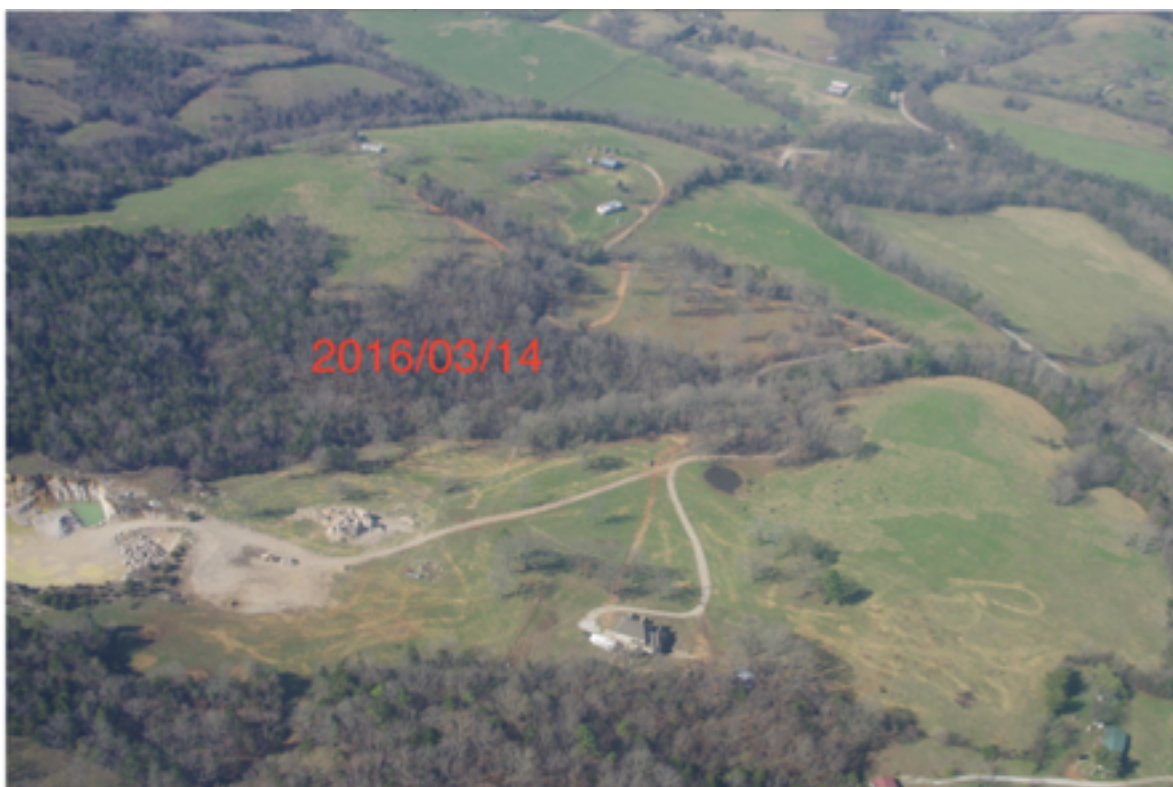
**FIGURE 3 AERIAL VIEW OF FIELDS 2 AND 3 SHOWING COW TRAILS AND OTHER EVIDENCE OF ERODIBLE CONDITIONS.**

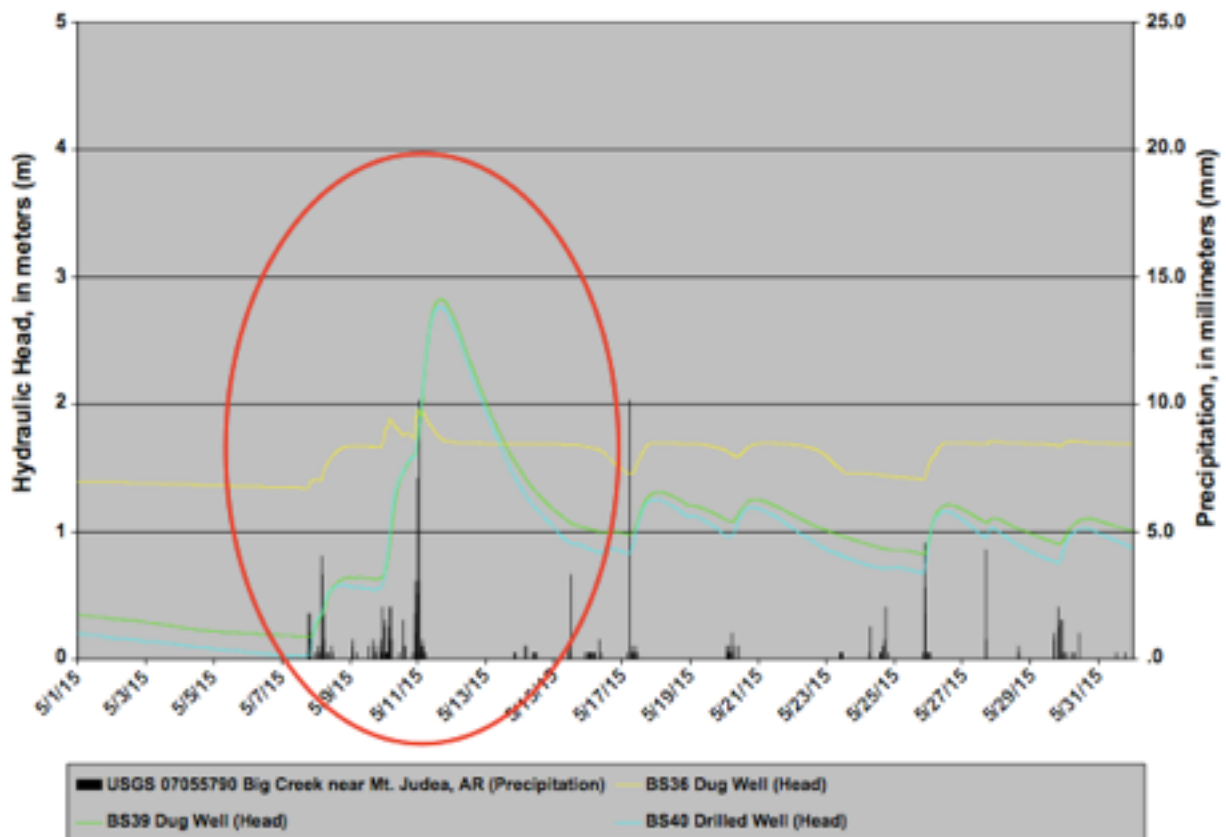
**Fig. 13** Hydrographs of three groundwater wells, BS-36, BS-39, and BS-40 for the month of May 2015. The hydrographs show the groundwater level (rise and fall) on the *vertical axis* plotted against time on the *horizontal axis*. As in Fig. 12, precipitation is shown by the *vertical lines* and the scales for the figures are presented in the same locations. The timing of the causes (precipitation) and effects (groundwater-level response) can be subtracted, and is called the lag time. In this case, the time lag was essentially zero, indicating that

groundwater levels started rising as soon as the precipitation started. The magnitude of the water-level increases is a reflection of the change in storage as the groundwater moves downgradient, and varies for different hydrologic settings in the Boone Formation (BS-36), the epikarst at the top of the Boone (BS-39), and the Big Creek alluvium and terrace deposits (BS-40) that lie above the Boone in Big Creek Valley

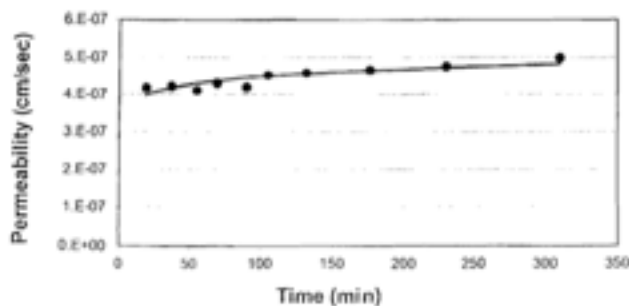
### HYDRAULIC CONDUCTIVITY TEST RESULTS

Hydraulic Conductivity Test Procedures Performed  
In Accordance With ASTM D 5084 Method C  
(Flexible Wall - Falling Head - Rising Tail)

Hydraulic Conductivity,  $k$  (cm/s): 5.E-07

Notes: Sample was recompacted at 98.1% of MOD at a moisture content of 21.2% (at OMC = 0.5%)

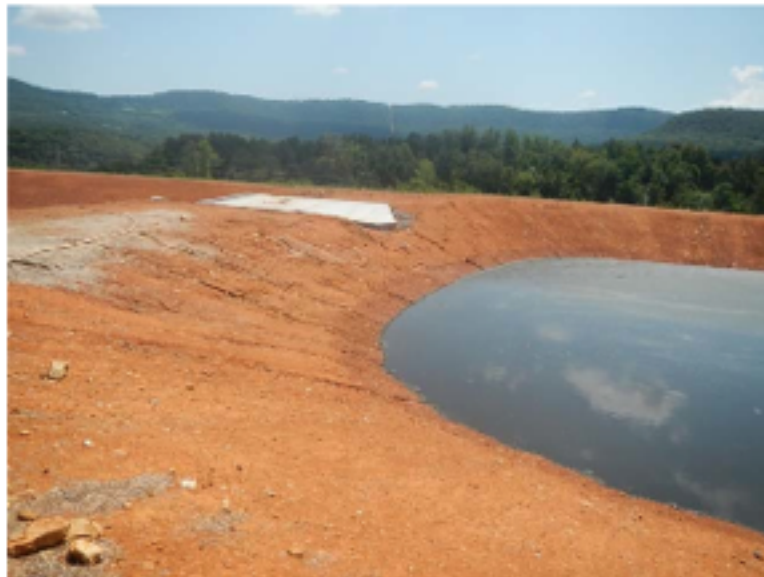
<b>Location:</b>	C&H Hog Farm, Newton County						
<b>Photographer:</b>	Tony Morris				<b>Witness:</b>	Phillip Campbell	
<b>Photo #</b>	5	<b>Of</b>	6		<b>Date:</b>	07/23/13	<b>Time:</b> 12:03
<b>Description:</b>	Rill erosion in Settling Basin liner; large rocks in liner. Signs of liner deterioration.

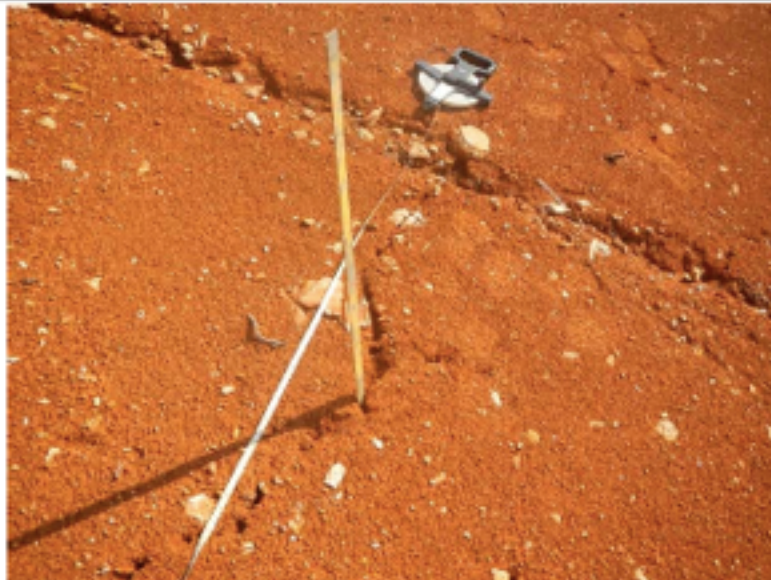
<b>Photographer:</b>	Tony Morris				<b>Witness:</b>	Phillip Campbell	
<b>Photo #</b>	6	<b>Of</b>	6		<b>Date:</b>	07/23/13	<b>Time:</b> 17:21
<b>Description:</b>	Rill erosion and desiccation cracks in Holding Pond liner due to extended exposure.

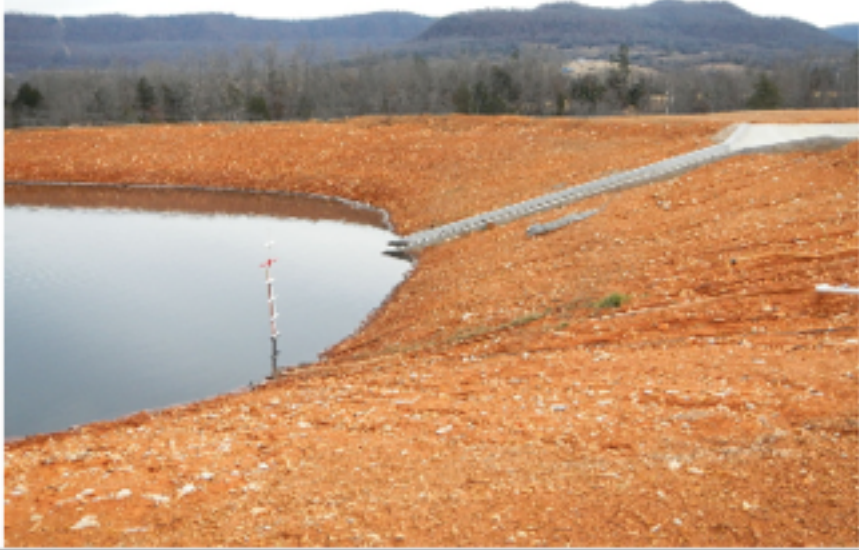
Water Division Photographic Evidence Sheet			
Location:	C&H Hog Farms		
Photographer:	Jason Bolenbaugh	Date:	1/23/2014
Time:	12:02	Witness:	John Bailey, Jason Henson
Photo #:	1	Description:	Inside of Holding Pond 2. Note erosion rills and unstabilized banks. Holding Pond Must Pumpdown elevation is indicated in red on the Must Pumpdown gauge.

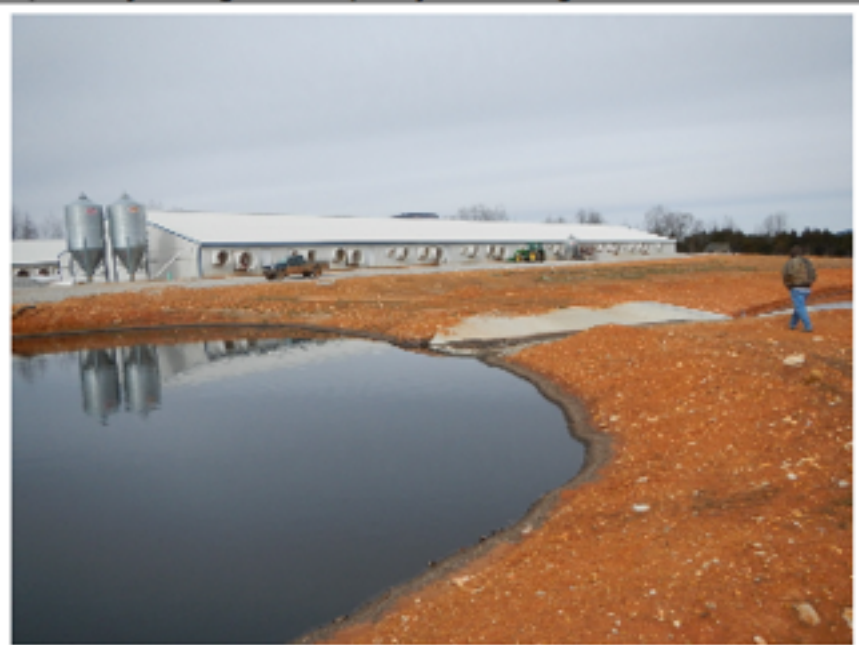
Photographer:	Jason Bolenbaugh	Date:	1/23/2014
Time:	12:16	Witness:	John Bailey, Jason Henson
Photo #:	2	Description:	Inside of Holding Pond 1. Note the unstabilized banks. Waste water is not currently running over the spillway into Holding Pond 2.

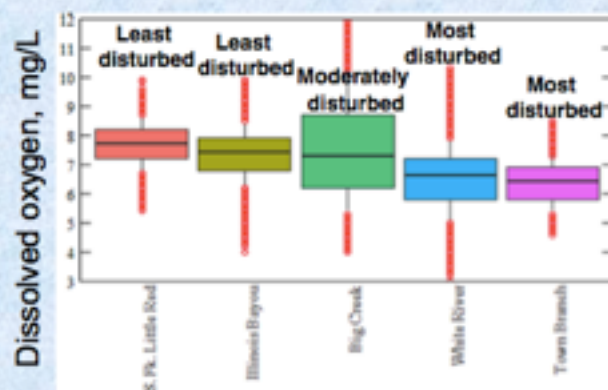
Continuous DO statistics indicated a strong connection between the nutrient and land-use indices and DO concentrations

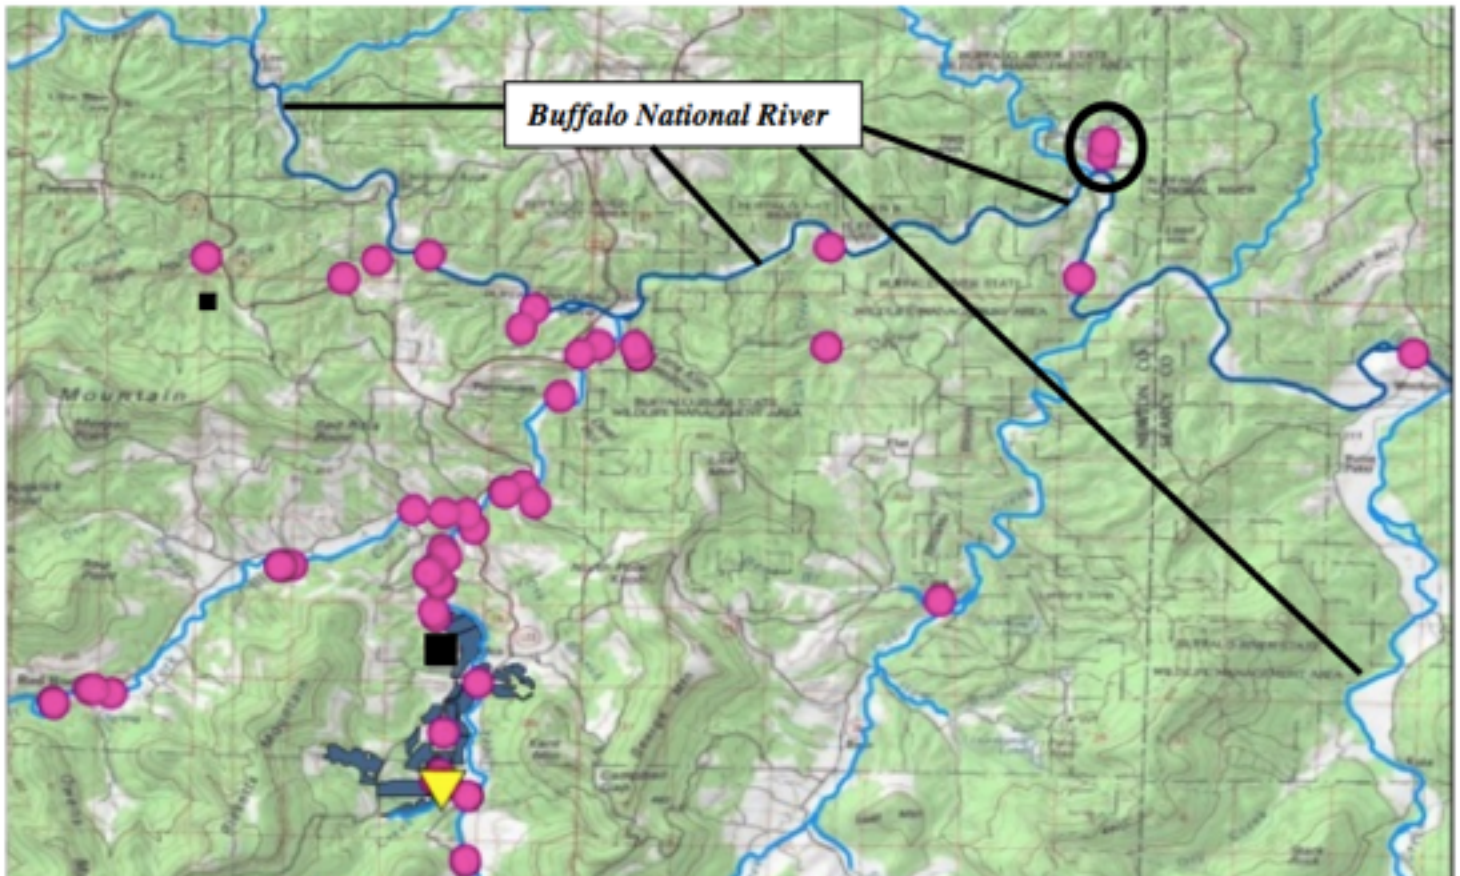
Figure 9. Flow from BS-36 where eosin input was positively traced to outflow springs and streams. This trace shows the full dispersive extent of karst flow in the subsurface into other surface water basins, the Buffalo National River, and even beneath the river to Mitch Hill Spring, identified by the black circle in the northeast quadrant. The yellow triangle is dye input well BS-36, blue shapes are hog-waste spreading fields, and the black rectangle is the CAFO. The Buffalo National River is the blue irregular sinuous feature that extends from the northwest to the southeast corner of the map. Pink circles are positive dye detections, five of which were retrieved from the rivet
